Manhole Inspection Summary

Manhole # S43MM_017MH

Insp Date: **4/23/08 2:04 PM**

Location Address: **Regester St**

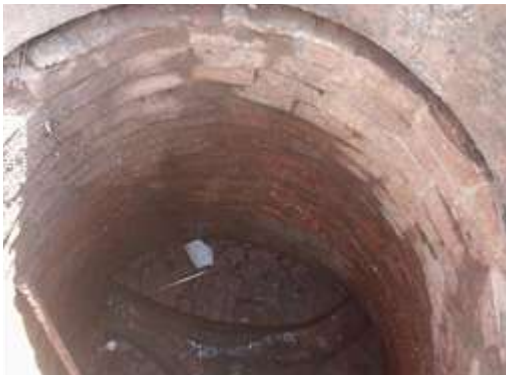
Defect 1

Frame Offset: **0.5** (in.) Condition: ☒ Sound ☐ Cracked ☐ Leaks

Frame Leaks

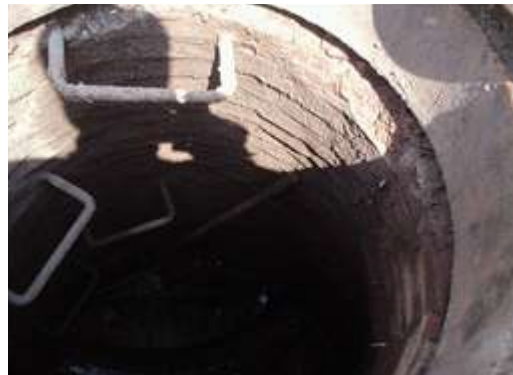
Defect 2

Condition: ☐ Sound ☐ Cracked ☐ Root Intrusion ☒ **Loose Brick** ☐ Deteriorated

Infiltration: ☐ None ☒ **Joint** ☐ Cracks ☒ **Mortar** ☐ Roots ☐ Wall

Loose Bricks

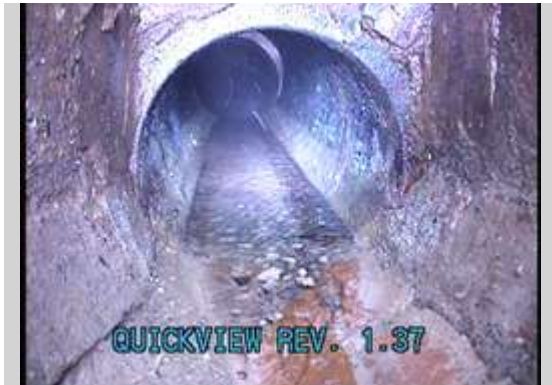
12 O'Clock Outflow

8 in. Circular Gravity Sewer
Pipe Out @ 12 O'Clock

Pipe Height: **8.4** (in.) Rod and Bar (Angled)
Pipe Material: **Clay** ☐ Pipe Lined
Invert Depth: **9.10** (ft.) Flow Characteristics: **Fast**
Deposits: ☒ None ☐ Mud ☐ Sludge ☐ Debris ☐ Grease
Silt Depth: (in.) Deposits Extent:
Infiltration: **None** Pipe Seal Cond: **Sound**

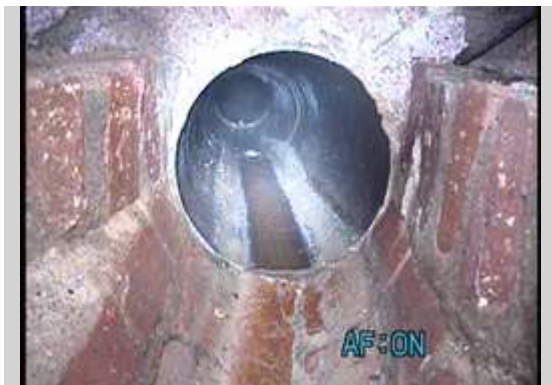
7 O'Clock Inflow

8 in. Circular Gravity Sewer
Pipe In @ 7 O'Clock

Pipe Height: **8.4** (in.) Rod and Bar (Angled)
Pipe Material: **Clay** ☐ Pipe Lined
Invert Depth: **8.50** (ft.) Flow Characteristics: **Fast**
Deposits: ☒ None ☐ Mud ☐ Sludge ☐ Debris ☐ Grease
Silt Depth: (in.) Deposits Extent:
Infiltration: **None** Pipe Seal Cond: **Sound**

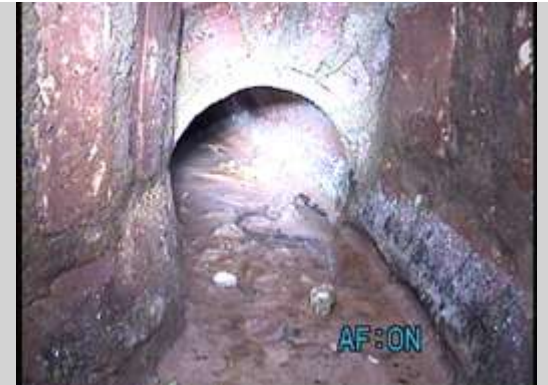
6 in. Circular Gravity Sewer

Pipe In @ 5 O'Clock

Infiltration: **None** Pipe Seal Cond: **Sound**
